**DEFECT INFORMATION REPORT FOR DAIMLERCHRYSLER RECALL #C43**

Safety Recall #C43 - Instrument Cluster Capacitor  
STOP SALE ORDER

## **Safety Recall No. C43** **Instrument Cluster Capacitor**

**2004 (HB) Dodge Durango**

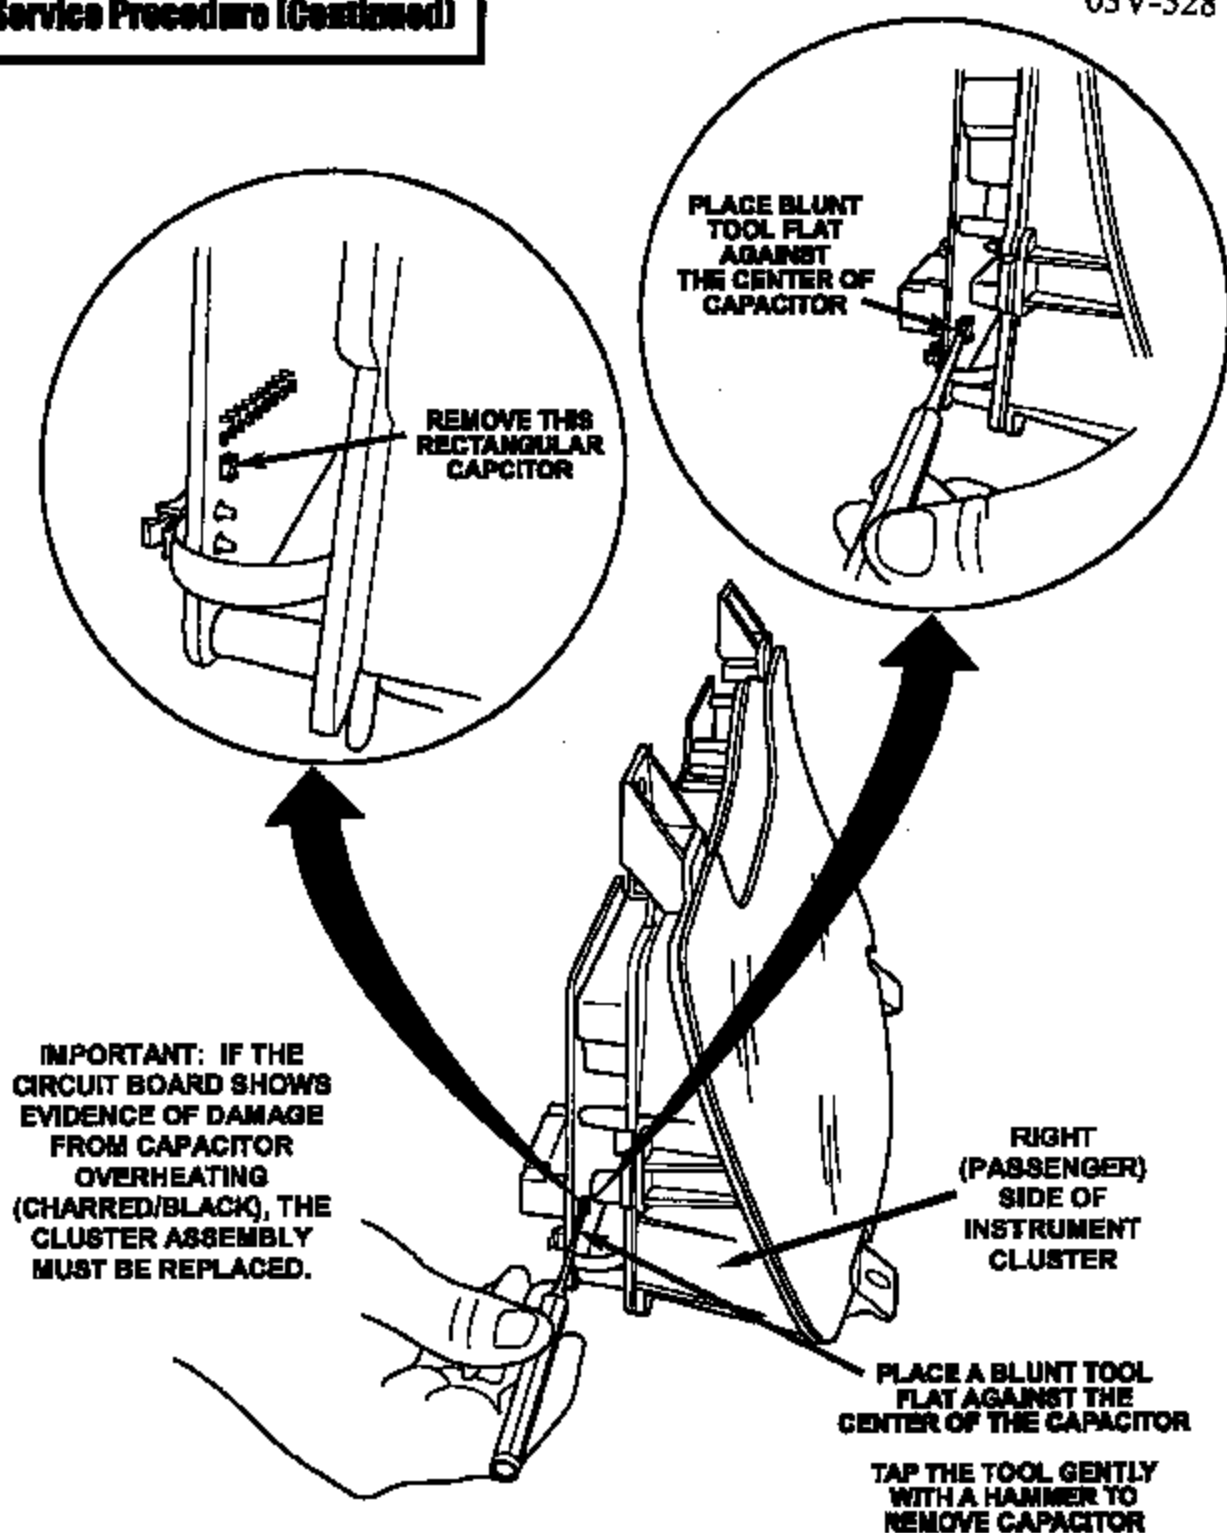
Figure 8

17. Place a **blunt tool** such as a 5/32" pin punch against the circuit board capacitor on the right (passenger) end of the circuit board (Figure 8). Do NOT use a tool that is wider than the overall width of the capacitor.

**IMPORTANT:** If the circuit board shows evidence of damage from capacitor overheating (charred/black), the cluster assembly must be replaced. Use normal service procedures to obtain a replacement cluster assembly.

18. **Gently** tap the tool with a small hammer to separate and remove the capacitor from the circuit board. Keep the circuit board in the vertical position so that the removed capacitor falls away from the cluster assembly.

19. Inspect the capacitor location and ensure that all of the capacitor material has been removed from between the two terminals and make sure that the capacitor has fallen away and is not trapped within the circuit board assembly.
